## ***City of North Miami Beach, Florida***

COMMUNITY DEVELOPMENT DEPARTMENT

SUBJECT: **Existing Conditions City Owned Parking Lot (Folio# 07-2217-006-0130) 1321 NE 162<sup>nd</sup> Street**

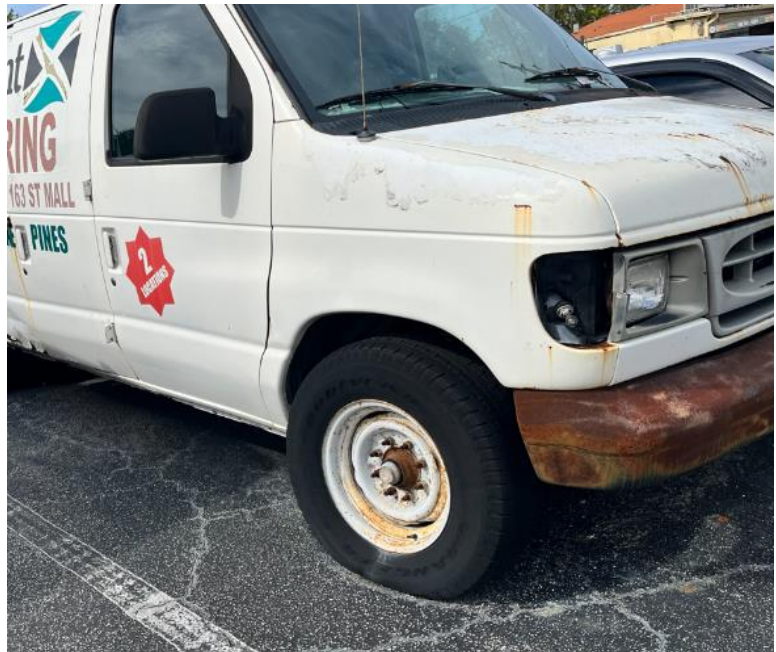
- Large pile of palm fronds in the eastern landscape buffer
- Pieces of plastic speed bumps, formerly installed in the alley discarded within the landscape islands
- Several commercial vehicles in poor repair (rust, flat/rotting tires, faded signage) with expired or missing tags, some occupying more than a single parking space
- Soil and sand sometime several inches deep accumulating on the pavement in several areas of the parking lot

**FIGURE 2: EXAMPLE OF COMMERCIAL VEHICLE IN DISREPAIR, WITH SEVERE RUST IN SEVERAL PLACES, BUSTED TURN SIGNAL, ROTTING TIRES, FADED MARKINGS, AND VEHICLE TAG EXPIRED SINCE 2019.**

The city should conduct a sweep of the parking lot to verify vehicle registration status and have such vehicles towed as a “nuisance” under the provisions of Section 10-4.3 j. of the Code of Ordinances of the City of North Miami Beach.

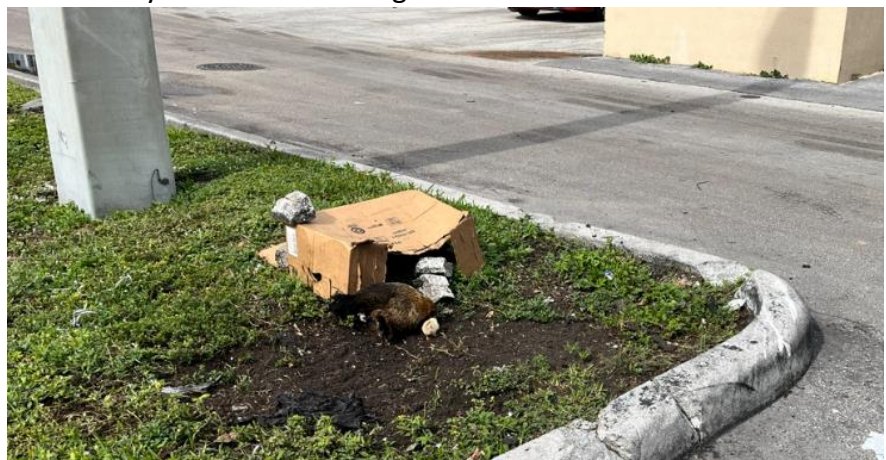
The four drive aisles are arranged between landscape buffers to at the western and eastern sides of the lot. The drive aisles and parking are separated from each other by three parallel landscape areas running north south connecting landscape islands on NE 162<sup>nd</sup> Street to the south and the alley to the north. These landscape islands are covered by a combination of grass and weeds with several areas of exposed soil.

**FIGURE 3: LANDSCAPE ISLAND WITH BROKEN CURBS, EXPOSED SOILS, AND A CARBOARD BOX PROVIDING TEMPORARY SHELTER TO SOME WILD**

by scattered trash and other items including milk crates, a cardboard box temporally housing some wild chickens with chicks, and parts of plastic speedbumps which were installed in the alley at some point.

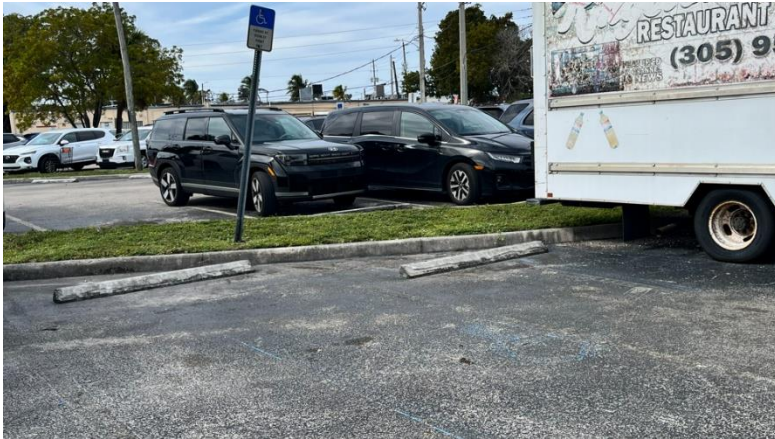
**FIGURE 4: IMAGE OF AN ADA PARKING SPACE WITH SEVERELY FADED AND/OR MISSING/INCORRECT MARKINGS**

places and severely faded in general. There are no arrow pavement markings indicating directionality as required for one-way drive aisles. Finally, the ADA space markings are severely faded the required blue color almost completely absent in places, access aisles missing/mismarked, and the wheelchair figure missing entirely.

The ADA Parking with this City owned parking lot was found to be non-compliant in terms of signage and pavement markings for the space and access aisle as well as the access route to the nearest walkway or building entrance. Other concerns include condition of pavement, curbs and wheel stops at these spaces and from these spaces to the building entrances or north side of city controlled alley ROW to the north of the lot. Note that during the site visit no smart level was deployed to determine if there are any slope or cross-slope issues with the existing ADA parking space locations or accessible route from these spaces to the nearest walkway or building entrance.

The city needs to evaluate the existing ADA parking space locations need to be evaluated from an engineering perspective to include count, location, accessible route(s), pavement condition, including slope and cross slope. This evaluation should result in a plan that will more fully determine what corrective actions are needed to ensure that this city owned parking lot is in full compliance with current ADA requirements to maximize public access, enhance conditions for area businesses, and reduce risks to the city. At a minimum one outcome of this evaluation should be a pavement marking plan to identify the ADA parking spaces (configuration, location and count), access aisles, and accessible routes

Once the short term actions above have been undertaken any portions of the lot needing slope or cross slope correction to meet ADA requirements for ADA parking spaces and accessible routes being repaved accordingly. Then the parking lot should be sealed with an asphalt sealer suitable for parking lots. The lot should then be restriped according to the restriping plan that was an outcome of the initial engineering evaluation, including all parking spaces, ADA markings, and directional indicators.

The required parking lot regulatory signage should be installed including but not limited to “Stop” and “Do not enter” signs. All ADA parking space regulatory signs need to be replaced with signs which cite either Florida Statute [FS 318.18(6) \$100 fine] or Miami-Dade County ordinance Sec 30-442 (d) stating “TOW AWAY ZONE AND FINE UP TO \$250.” ADA parking spaces without signage specifically citing either the Florida Statute or the MDC Ordinance are not enforceable.

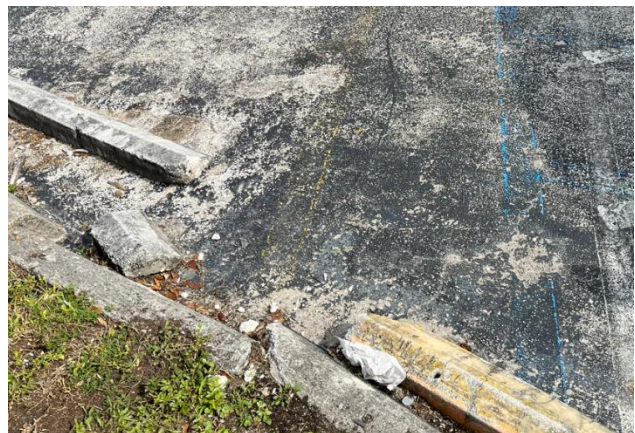
The parking lot has both concrete curbs and wheel stops. The curbs define and protect the landscape islands throughout the property and within the NE 162<sup>nd</sup> Street ROW. The curbing is generally in decent shape; however, several areas are broken up, particularly near the alley, likely due to repeated incursions by heavier commercial vehicles. The curbing is set in a straight pattern as it defines the parking aisles not the “sawtooth” pattern that would be typical of angle in parking less than 90 degrees. The angle of the parking is defined by the wheel stops. These wheel stops,

**FIGURE 5: BROKEN CURB, BROKEN WHEEL STOP, AND ANOTHER MISPLACED WHEEL STOP**

which are made of concrete generally in good shape, but several are misplaced or missing with some broken examples as well. These curbs and wheel stops should be painted in key locations, along the alley to increase visibility and at the ADA parking spaces to enhance awareness. Finally, all wheel stops should be painted or replaced with higher visibility colored plastic versions, preferably with retroreflective features (side note wheel stops are considered hazardous to many within the ADA and senior advocacy community to possible trip and fall risk).

The city should remove any broken wheel stops and reset displaced wheel stops if possible. This is a short term action to reduce trip hazards. In the longer term wheel stops should all be reset or replaced as part of a project to reseal and restripe the parking lot.

As part of the asphalt resealing and restriping project all wheel stops (existing or replacements) should be reset based on engineering standards. All curbs and wheel stops associated with ADA parking spaces should be painted to increase visibility of the ADA spaces.
